REPORT OF TELEVISION BOREHOLE SURVEY  
OF WELL NUMBER 3  
Iroquois Service Area  
New York State Thruway

March 20, 1970

Project: Well Number 3  
Iroquois-Indian Castle Service Area  
Project No. E101254-071

Subject: Television  
Borehole Survey

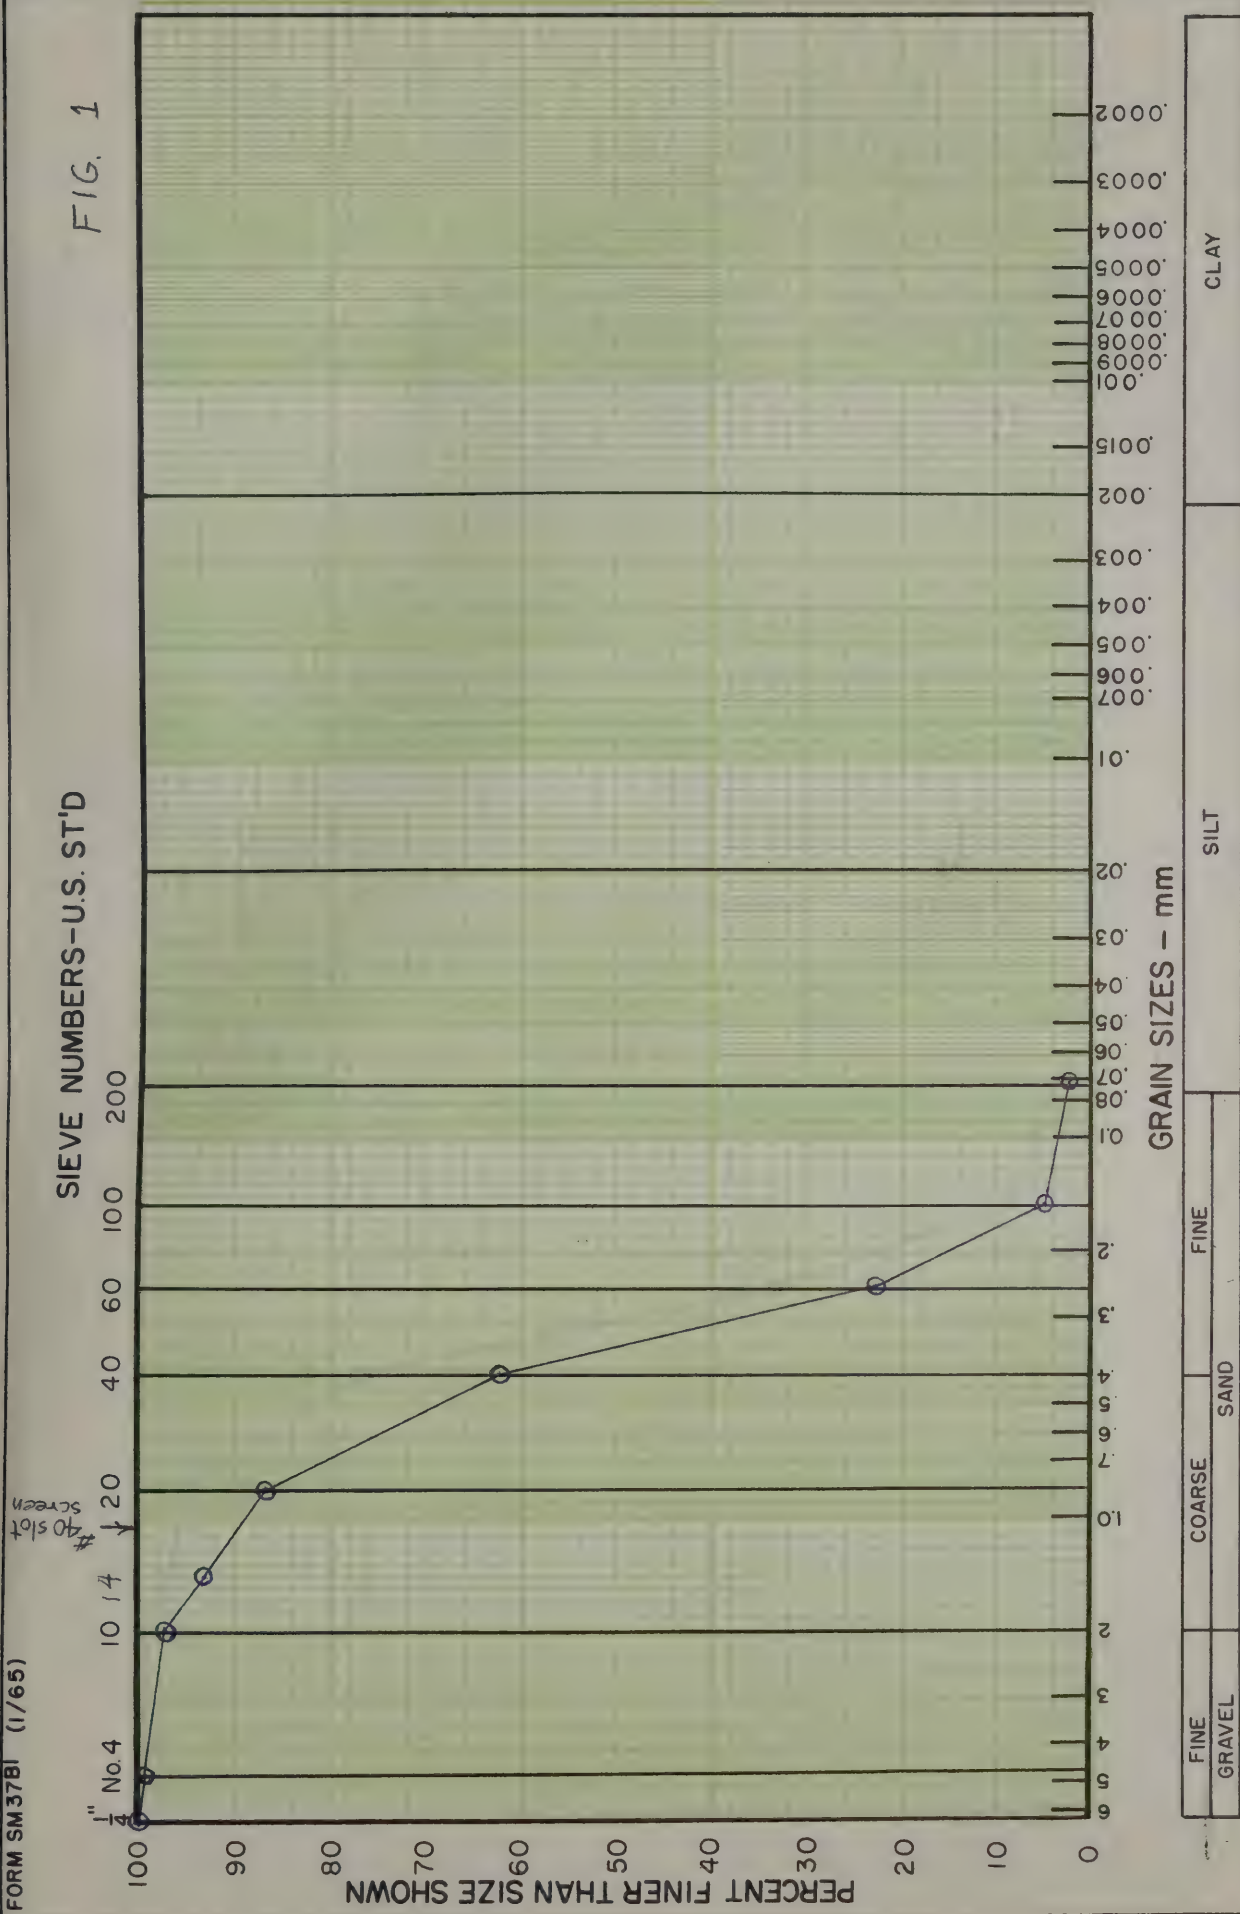
FIG. 1

Plates IV & V show the material recovered by the bailer separated according to that passing or being retained by the No. 14 sieve. The coarser material consists mainly of rust particles from the casing. There are a few pieces of sandstone and crystalline too coarse to be passed by the well screen. They may have entered the well between the casing and the screen since the seal is no longer present. Figures 1 and 2 show the grain size analysis of the samples taken by the bailer and from the softening wier respectively. Over 90% by weight of the material in both samples could pass a No. 40 well screen. Over 90% of the remaining material is rust particles from inside the casing.

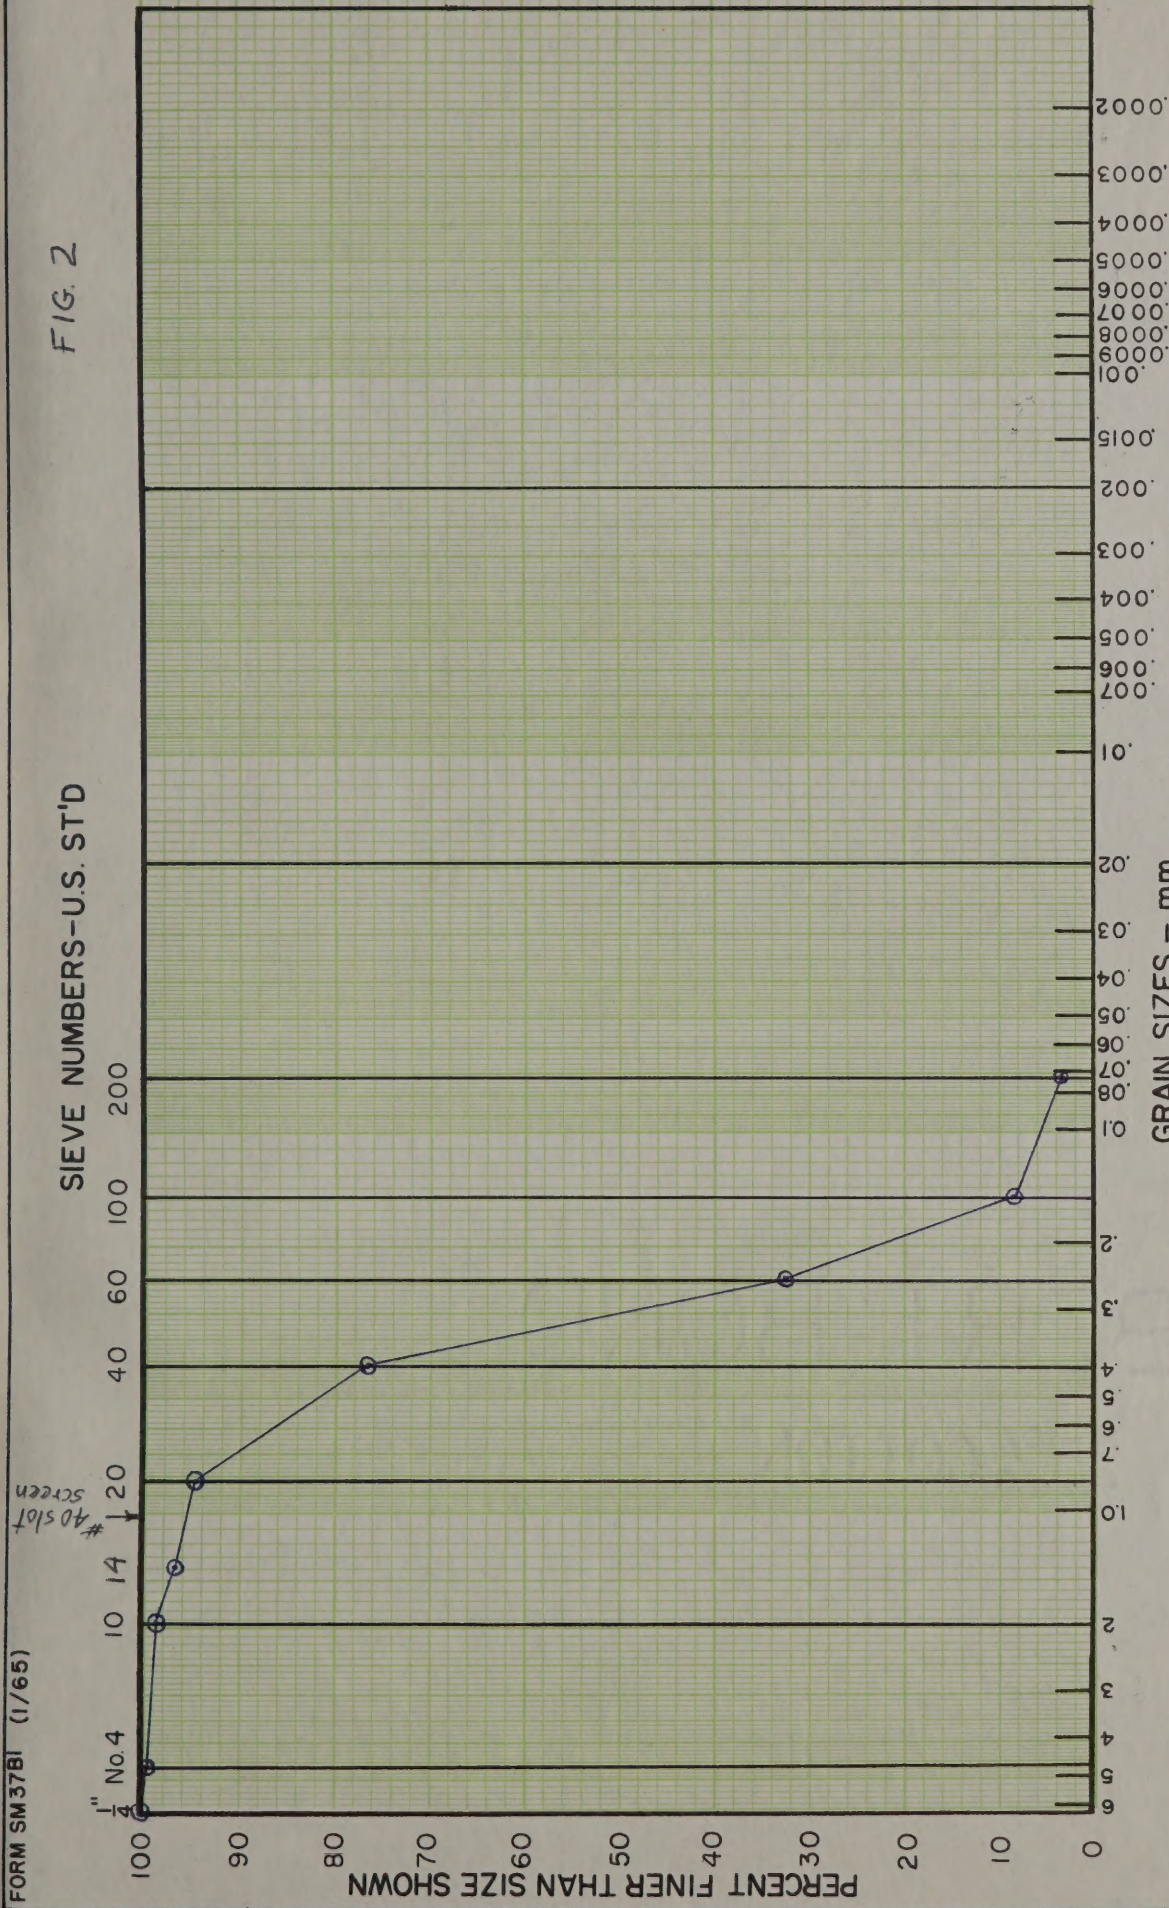
FIG. 2

Placas IV & V show the material recovered by the bailer separated according to that passing or being retained by the No. 10 sieve. The coarsest material consists mainly of rust particles from the casing. There are a few pieces of sandstone and crystalline too coarse to be passed by the well screen. They may have entered the well between the casing and the screen since the seal in no longer present. Figures 1 and 2 show the grain size analysis of the samples taken by the bailer and from the softening wire respectively. Over 90% by weight of the material in both samples could pass a No. 40 well screen. Over 90% of the remaining material is rust particles from inside the casing.
